ARCHAEOLOGICAL ASSESSMENT

**PROPOSED RESIDENTIAL SUBDIVISION
DEVELOPMENT
WITHIN
LOT 3 DP 514174**

**23 KAHIKATEA DRIVE
KINLOCH**

MARCH 2020

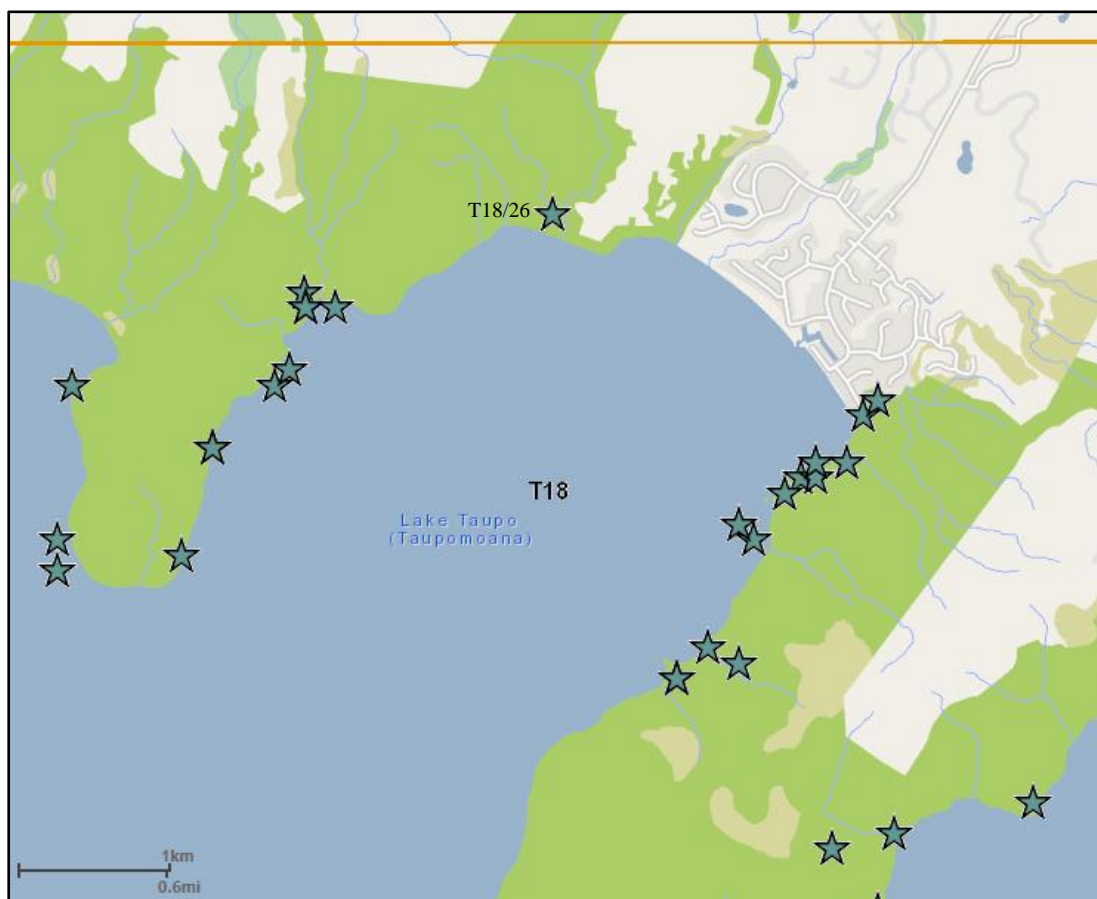
The coordinates for sites recorded by Fletcher have not been updated since they were visited in the 1970s consequently, they retain a potential inbuilt error margin of 100m until more accurate GPS coordinates have been established. Fletcher's survey also appears to have focused on the coastal margins of the bay and does not appear to have inspected inland areas including Lot 3 DP 514174. Consequently, much of the Kinloch area must be considered unsurveyed.

Figure 7. Plan showing the location of recorded archaeological sites within Whangamata Bay.
